Improved Methodologies for Identifying Root-Cause of Printed Board Failures

C. Hillman

DfR Solutions, College Park, MD

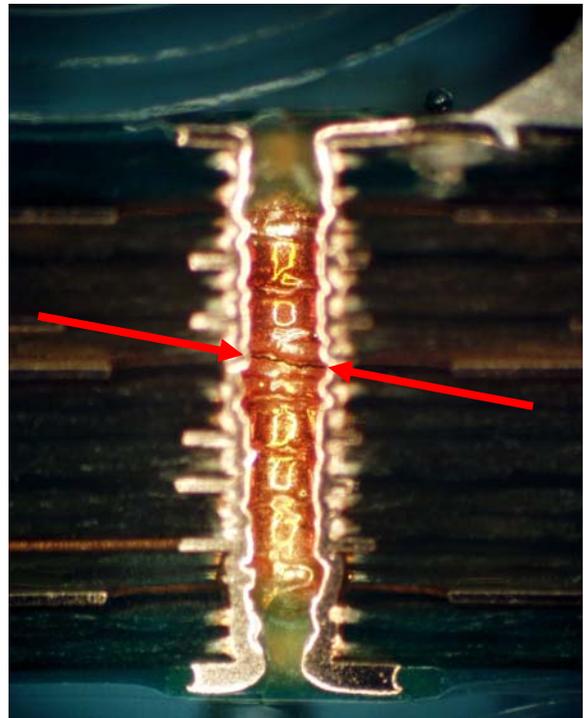
Figure 1: Optical micrograph of a cross-sectioned plated through hole in a FR-4 printed circuit board. The red arrows mark the appearance of circumferential crack in the copper barrel.

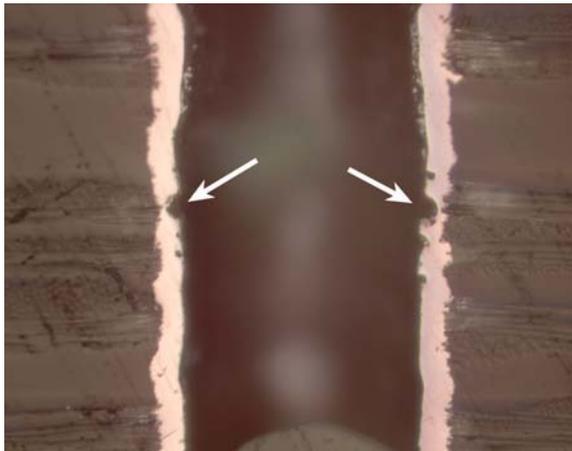
Etch pits are the result of etchant residues residing in the plated through hole barrel. The primary source of etchant residues are the chemicals used in the outer layer stripping process. Etchants can also be introduced if the bare board is reworked, such as stripping of the solderability coating. These etch pits can range in size from small 'mouse bites', shown in Figure 2, to complete removal of large sections of the PTH wall (seen in Figure 3). Etchants can also become trapped when vias are tented on only one side.

Figure 2 (120x): Optical micrograph of a cross-sectioned plated through hole in a FR-4 printed circuit board. The white arrows mark the appearance of etch pits, which resulted in circumferential crack propagation.

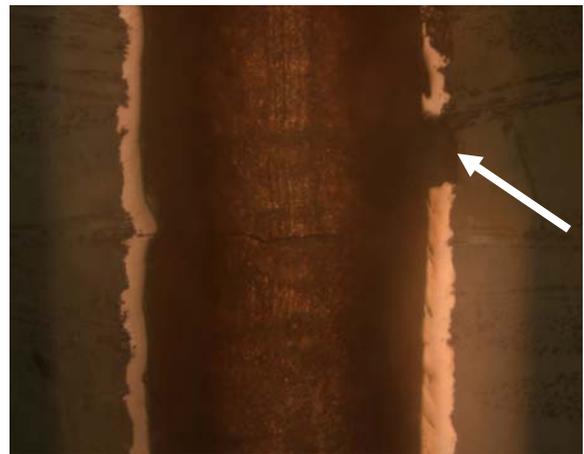
Figure 3 (120x): Dark field optical micrograph of PTH with suspected etch pit (marked by white arrow).

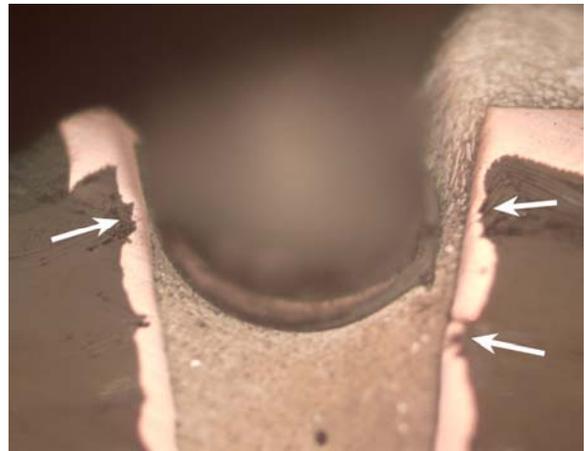
Glass fiber protrusion into via walls also affects via plating thickness and hence can contribute to via cracking. Glass fiber protrusion may be due to process control variabilities during hole drilling, hole preparation or application of flash copper. Glass fiber protrusion is allowed by IPC guidelines for rigid copper boards only if the minimum copper plating thickness is met.

Figure 4 (120x): Optical micrograph of glass fiber bundle protrusion (marked with the white arrows).

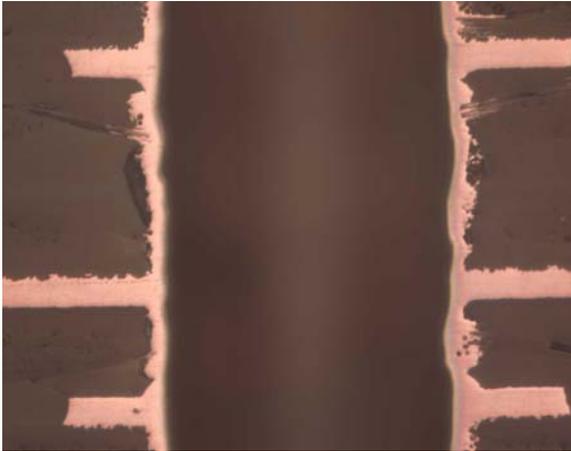
Insufficient plating thickness can lead to a reduction of mechanical and thermal properties and may lead to fatigue or overstress cracking. According to ANSI/IPC-A-600F [13], minimum acceptable average plating thickness for a Class 1¹ product is 20 microns, with isolated areas allowed to reach 15 microns in thickness. This specification is based on the minimum thickness that will reliably withstand multiple solder floats. The PTH shown in Figure 5 has an average plating thickness of approximately 18 microns with isolated areas reaching a thickness of 10 microns.

Insufficient plating thickness is caused by either insufficient current/time in the copper plating bath or poor throwing

power. Poor throwing power² often provides uneven plating in the barrel, with thickness decreasing towards the center of the board. This is especially the case in high aspect ratio (greater than 4:1) PTHs, where it becomes necessary to use plating solutions operating under special conditions of low copper content, high sulphuric acid, low current density and low temperature. Since insufficient plating thickness was observed throughout the PTH, instead of just at the center of the board, the root-cause was determined to most likely be insufficient current or time in the copper plating bath.

Figure 5 (120x): Optical micrograph of a cross-sectioned plated through hole in a FR-4 printed circuit board with insufficient plating thickness.

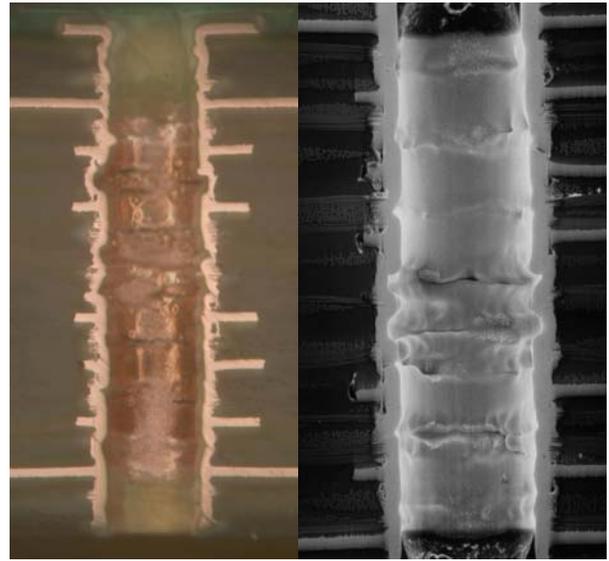
In addition, plating folds can reduce via life through the creation of stress concentrations [5]. Rough drilling or improper hole preparation can cause plating folds. Rough drilling can be caused by poor laminate material, worn drill bits, drilling equipment that is not calibrated or maintained, or a drilling process that is not optimized. Improper hole preparation is often due to excessive removal of epoxy resin caused by incomplete cure of resin system or a preparation process (desmear/etchback) that is not optimized.

Figure 6: Optical and electron micrographs of plated through hole with deep folds in the plating.

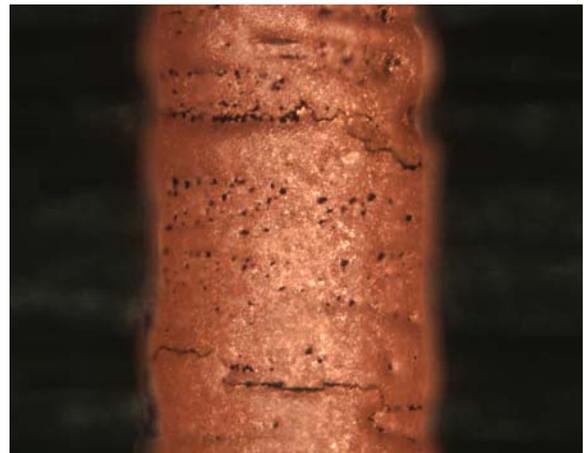
Plating voids are areas where the copper fails to deposit or plates more slowly than in surrounding areas. The cause is often linked to the presence of air bubbles on the surface of the base material. Air bubbles are caused by supersaturation. Supersaturation can occur due to air entering the filter system, creating microbubbles within the solution. In addition, a rise in the temperature of the plating bath can create plating voids by

Figure 7 (120x): Dark field optical micrograph of PTH with extensive voiding and cracking in the barrel wall.

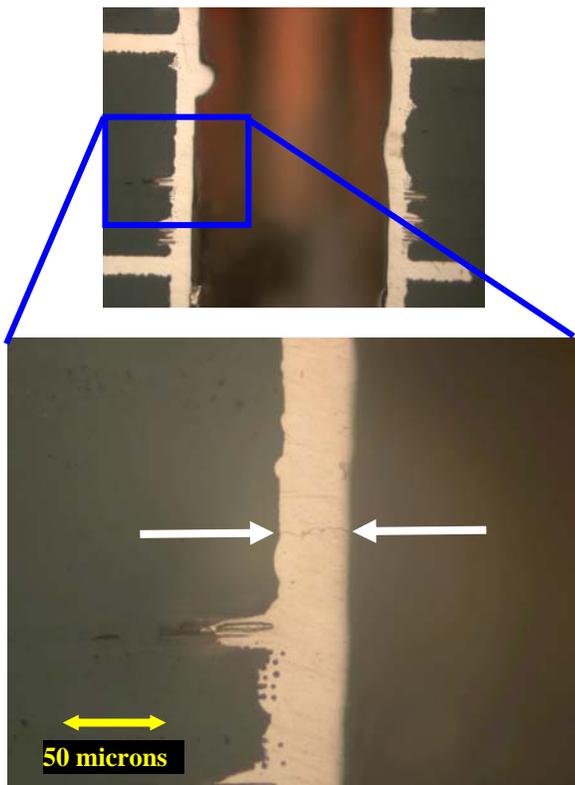
This has resulted in the potential for 'nominal' PTHs (nominal according to observation of the cross-section) to experience circumferential fatigue during the expected lifetime. An example of this conundrum is shown in Figure 8.

Figure 8 (300x): Optical micrograph of cross-sectioned plated through hole with plating cracks (marked by white arrow)

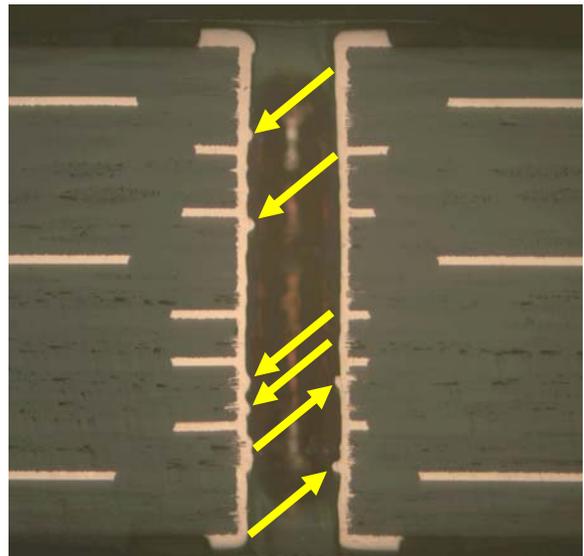
No gross defects or violations of IPC specification were identified. The average plating thickness was approximately 35 μm with no point less than 23 μm . The only anomalies identified were plating nodules. The worst case observed is displayed in Figure 10.

Figure 9 (30x): Optical micrograph of cross-sectioned plated through hole. Yellow arrows mark plating nodules

Plating nodules were found on all of the PTH's examined. Root causes of nodulation include poor drilling, particles in solution, solution temperature out of range, or brightener level in excess. The relatively straight hole walls and the lack of particles in the nodules seemed to suggest the later two as root cause. The presence of plating nodules can be detrimental to high reliability. Plating nodules create highly stressed areas in the plating wall and can possibly reduce lifetime under temperature cycling. The target condition for nodules in IPC-A-600 is that there is no evidence of nodules.

However, the acceptable condition for all class of product (1, 2, and 3) is that the presence of nodules must not result in the minimum hole diameter below the minimum specification. Therefore, technically the contract board manufacturer was not in violation of IPC-A-600, even though they did not meet the target condition.

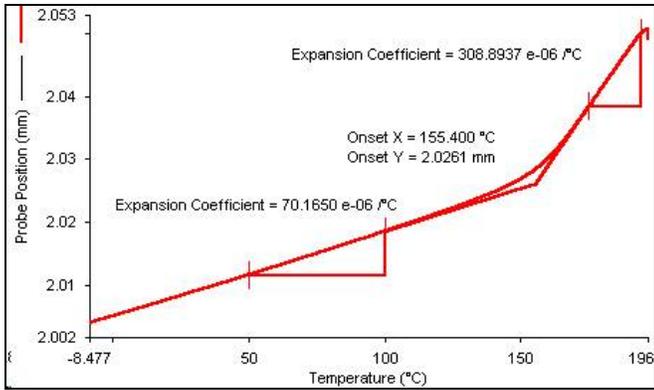
The percent cure and material properties of the FR-4 laminate were measured using a differential scanning calorimeter (DSC)(Perkin Elmer Pyris-1) and a thermo mechanical analyzer (TMA)(Perkin Elmer TMA-7) A cyclic DSC test, consisting of ramping a sample of the board from room temperature to 200°C and back several times, showed no hysteresis behavior, suggesting that the board was fully cured. The results of TMA testing are displayed in Figure 10. The glass transition temperature, T_g , was found to be 155°C, above the original specification of 150°C. The out-of-plane coefficient of thermal expansion, CTE, of 70 ppm was well within the expected 60-90 ppm range of standard FR-4 printed boards.

Figure 10: Out-of-plane temperature-expansion curve of a FR-4 printed board subjected to thermo mechanical analysis

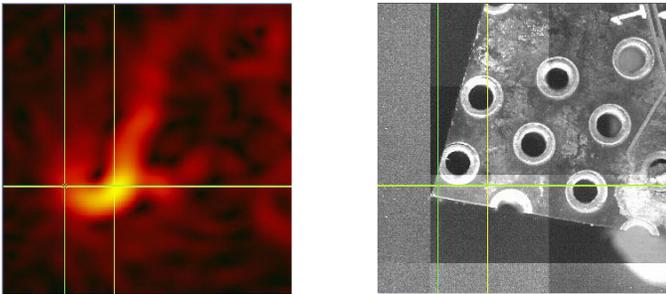
The results from performing SQUID microscopy on a shorted board are displayed in Figure 11. The bright yellow area on the current map corresponds to the area of highest current density. This is representative of necking down of the conductor path, which is often a strong indication of an electrical short. Cross-sectioning of the board was performed at this location based upon the SQUID image.

Figure 11: Current map (left) and corresponding photograph (right) of an electrically shorted printed circuit board.

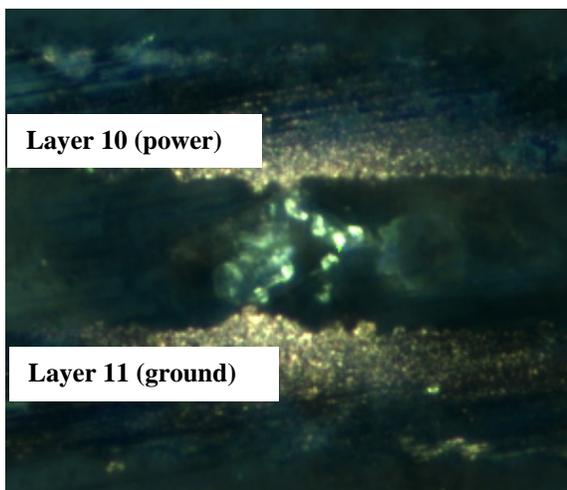
The results of the cross-sectioning are displayed in Figure 12. A large, angular particle is observed bridging the dielectric between the power and ground planes. Tangential evidence, including mounding of copper at the power and ground planes and blackening of the surrounding dielectric material, strongly suggested that the particle was the cause of the drop in internal resistance. Definitive findings were provided through SQUID imaging of the cross-section

Figure 12 (500x): Particle identified between internal power and ground planes in the approximate area of electrical leakage.

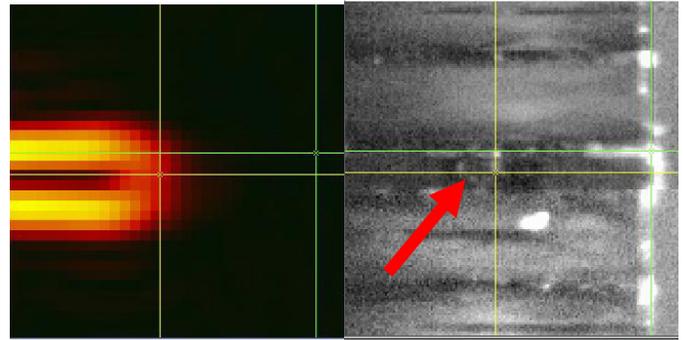
The SQUID images are shown in Figure 13. The results clearly demonstrate that current is flowing through the particle, therefore verifying that the identified particle is the location of the short. However, bridging alone can not explain the electrical failure. This is because the angular nature of the particle suggests that it is electrically insulative. An additional mechanism, known as electrochemical migration (ECM), was most likely required.

Figure 13: Current map (left) and corresponding optical image (right) of the board cross-section shown in Figure 12. The red arrow identifies the particle sandwiched between layers 10 and 11.

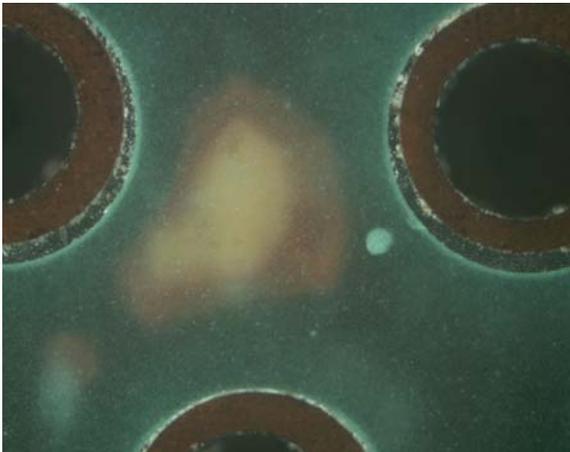
There is some evidence that the observed particles were reactive even without the presence of a voltage bias. During visual examination of the printed wiring boards, small discolorations were observed on the surface (see Figure 14). Cross-sections determined that the presence of particles corresponded to these discolorations. The particles seemed to attack the oxide bond, leading to localized delamination. The most likely corrosive element that led to oxide debonding is hydrochloric acid (HCl). The presence of extractable chlorides and moisture condensation can often lead to the formation of HCl.

Figure 14: Optical image of discolorations observed in the printed board

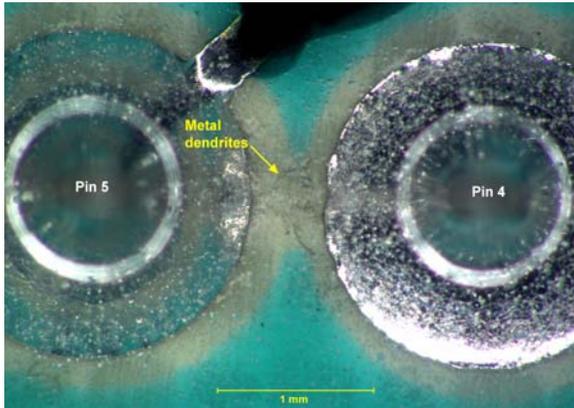
For a given design, and assuming a uniform distribution of contaminants, the primary driver for electrochemical migration (ECM), also known as dendritic growth, is the strength of the electric field between conductors. The visual inspection therefore focused on high voltage and fine pitch areas of the board. The results of visual inspection are displayed in Figure 15. Dendritic growth between solder pads on an insertion-mount microprocessor was observed using optical microscopy.

Figure 15: Optical micrograph of dendrite growth observed between two insertion mount pins

While the failure mechanism was conclusively identified, corrective action cannot be implemented until the root-causes are identified. For ECM, this consists of identifying the source of contamination.

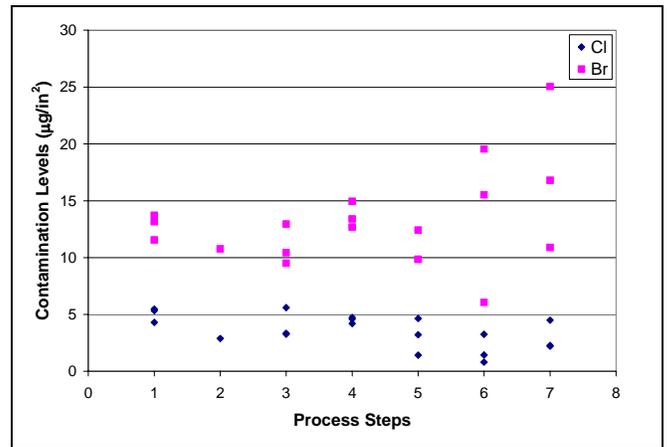
The results of IC are displayed in Figure 17. The incoming bare boards from the board manufacturer showed elevated levels of chloride and bromide ions, approximately 5 and 12 micrograms/square inch, respectively. These values violate some, but not all the specifications listed in Table 6. The contamination levels remained relatively constant until after conformal coating, which consists of an ultraviolet (UV) cure that can elevate the temperature of the board up to 80°C. After conformal coating, bromide levels increased to 20 to 25 micrograms/square inch.

These elevated levels of bromide exceeded all recommended maximums detailed in Table 6. While the board supplier was requested to respond to the relatively high levels of chloride and bromide on the bare board, further investigation focused on the source of the elevated bromide level after the application of the conformal coating.

Figure 17: Chloride and bromide levels measured by ion chromatography

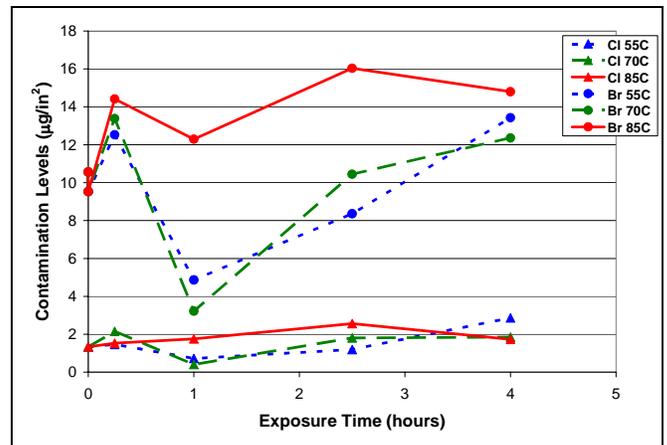
The potential source of elevated bromide levels was either the conformal coating or the application of temperature to the bare board. Ion chromatography of constituents of the conformal coating detected no chloride or bromide. To examine the influence of temperature, 12 bare boards were subjected to accelerated testing at 55°C, 70°C, or 85°C. Samples were removed after 15, 60, 150, and 240 minutes and subjected to ion chromatography. The results are displayed in Figure 18

Figure 18: Change in halide concentration as a function of time and temperature of exposure.

The bromide levels can be seen to experience large variations depending on the time and temperature of exposure. After 15 minutes, at all temperatures, 55°C, 70°C, and 85°C, the bromide levels rose slightly. This may indicate that superficial surface contamination retained through adhesion was released by the increased energy available at higher temperatures. After one hour, the bromide levels dropped, with the magnitude of the decrease partially dependent on the temperature. This could imply volatilization of the surface contamination, which is inline with the measurements after 15 minutes of exposure. That is, the contamination was weakly bonded to the surface.
