# A Novel Approach to Identifying and Validating Electrical Leakage in Printed Circuit Boards through Magnetic Current Imaging

*Craig Hillman*

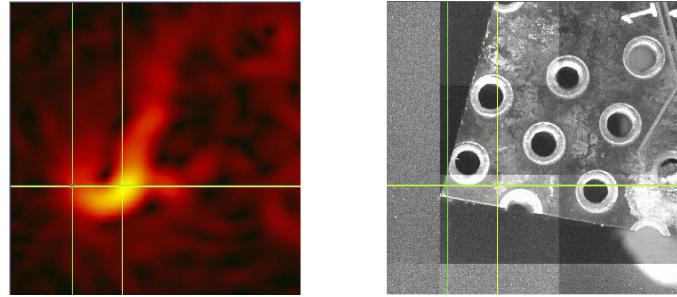
The results from performing SQUID microscopy on a shorted board are displayed in Figure 1. The bright yellow area on the current map corresponds to the area of highest current density. This is representative of necking down of the conductor path, which is often a strong indication of an electrical short. Cross-sectioning of the board was performed at this location based upon the SQUID image.

*Figure 1: Current map (left) and corresponding photograph (right) of an electrically shorted printed circuit board.*

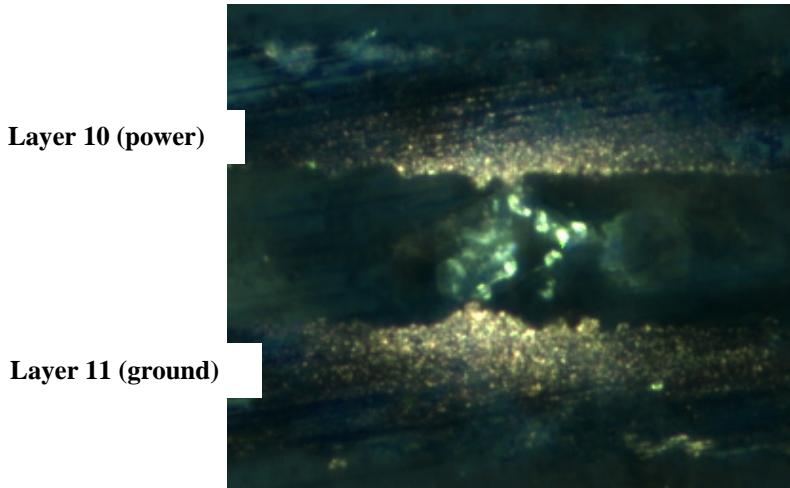
The results of the cross-sectioning are displayed in Figure 2. A large, angular particle is observed bridging the dielectric between the power and ground planes. Tangential evidence, including mounding of copper at the power and ground planes and blackening of the surrounding dielectric material, strongly suggested that the particle was the cause of the drop in internal resistance. Definitive findings were provided through SQUID imaging of the cross-section

*Figure 2 (500x): Particle identified between internal power and ground planes in the approximate area of electrical leakage.*

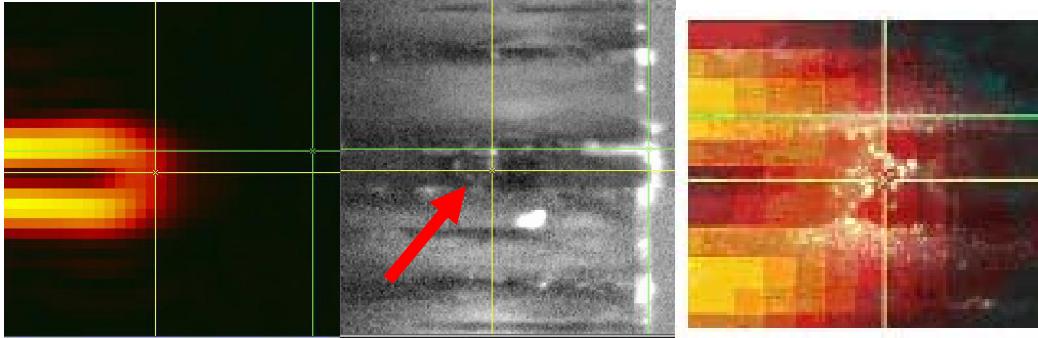
The SQUID images are shown in Figure 3. The results clearly demonstrate that current is flowing through the particle, therefore verifying that the identified particle is the location of the short. However, bridging alone can not explain the electrical failure. This is because the angular nature of the particle suggests that it is electrically insulative. An additional mechanism, known as electrochemical migration (ECM), was most likely required.

*Figure 3: Current map (left) and corresponding optical image (center) of the board cross-section shown in Figure 2. The red arrow identifies the particle sandwiched between layers 10 and 11. A higher resolution overlay is shown on the right.*
