# Let it flow

While much of the fame and glory, and money, may go to semiconductor manufacturing, the fabrication of printed circuit boards (PCBs) can often be a more difficult and challenging endeavor. Complex composites with anisotropic properties that change with time and temperature can be difficult to predict and control. An excellent example of this was a root-cause analysis performed on a board-mounted power supply that experienced a thermal event.

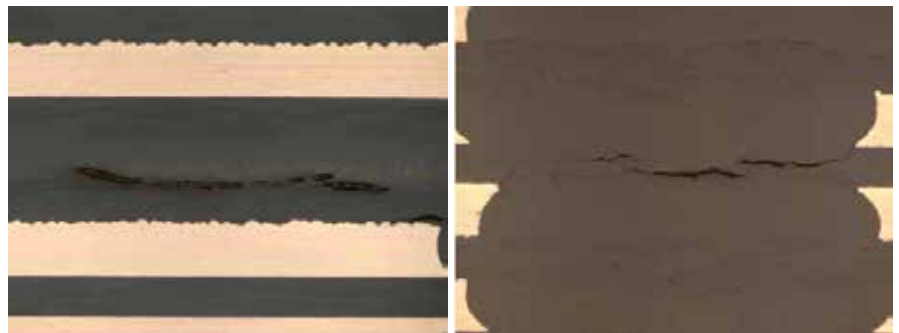
Observations of cross-sections from the first step (similar area, different PCB) showed indications that resin was unable to flow during lamination. Inability to flow resulted in some areas starved of resin. Other areas may have experienced severe stresses, resulting in crack propagation. The differentiation is based upon the edges of the anomaly. In the resin starvation image, the edge of the anomaly is rounded. In the cracking image, the edge of the anomaly is pointed (Figure 1)

Figure 1. Resin starvation (left) and cracking (right).

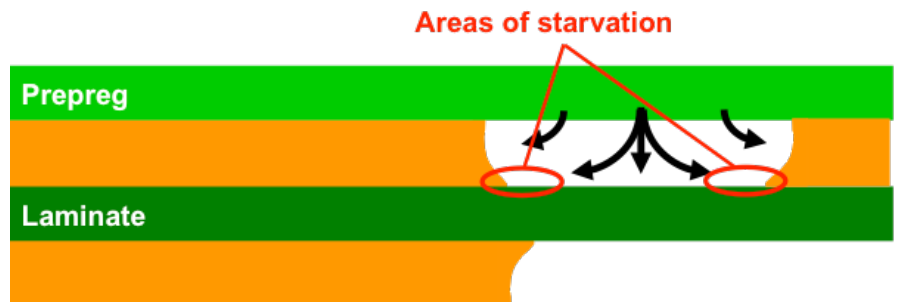
The resin starvation seemed to be affiliated with the edges of the copper foil, where it would be the most difficult for the resin to flow (Figure 2).

Figure 2. Illustration of resin starvation.

While identifying the root cause was relatively straightforward, preventing it from occurring in the future is much more challenging. Larger amounts of resin can prevent resin starvation and can allow the PCB vendor to reduce the amount of pressure being applied during lamination. However, larger amounts of resin, in combination with the thick copper planes, can greatly reduce time to failure during power cycling. How to optimize so no one failure mode dominates (or, preferably, even occurs)? Physics of failure.

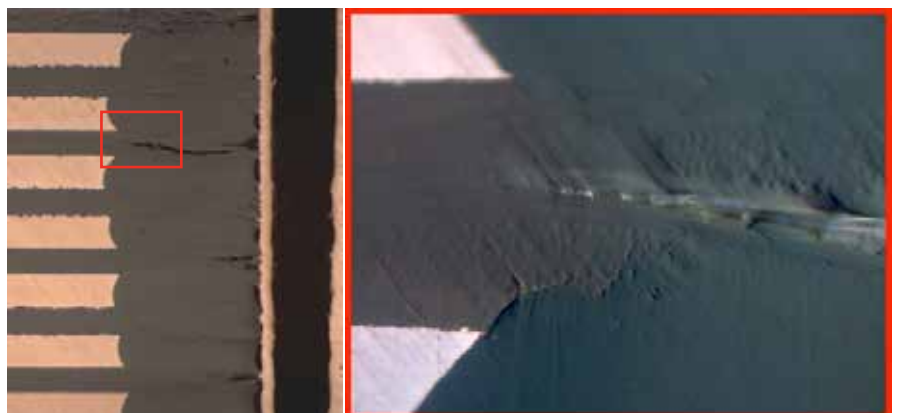
Figure 3. Void/delamination from resin starvation is linked to cracks emanating from the copper foil.

The first potential driver for failure was the intersection of the two types of anomalies. As seen in *Figure 3*, the void/delamination from resin starvation linked to cracks emanating from the copper foil. This junction provided a clear and complete path for metal migration from the internal plane to the plated through via. When the step of path formation is eliminated, CAF or metal migration can occur relatively rapidly (minutes to hours), even under relatively benign conditions, due to capillary condensation. The condensation event can immediately create an electrolytic cell and can extract contaminants from the epoxy resin.

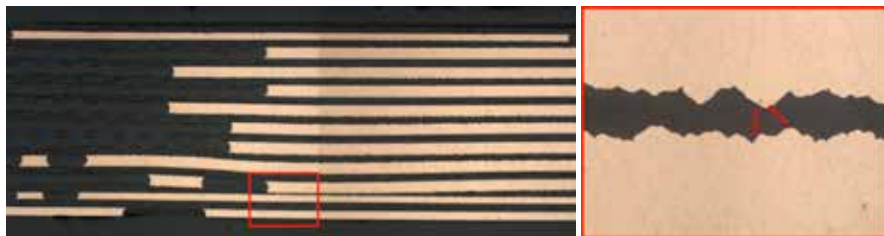
Continued inspection of the cross-section then noted a second potential failure inducing flaw. The anomaly was internal deformation, specifically of the copper foil and the prepreg material. The deformation of the copper foil resulted in spacings as small as 20 microns between internal planes. Is this degree of separation sufficient to have induced infant mortality due to dielectric breakdown?

At first pass, a review of these numbers would seem to suggest that TDDB was unlikely. Assuming a 15 micron spacing and a potential of 48 VDC, the resulting electric field stress of 3200 V/mm is an order of magnitude below the specified dielectric strength. However, there are two potential scenarios where the expected 30 kV/mm strength may not be present.

*Figure 4. Another potential failure-inducing flaw: deformation of the copper foil resulted in spacings as small as 20 microns between internal planes.*

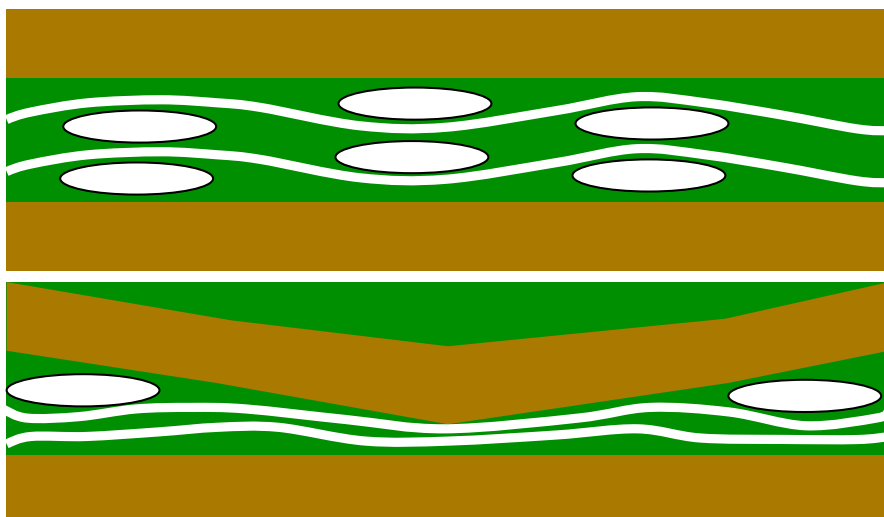
*Figure 5. During deformation of the internal planes, the laminate weave can become displaced.*

As seen in *Figure 5*, during deformation of the internal planes, the laminate weave can become displaced. If the displacement is severe, then there is a possibility that the fibers of the two plies will come into contact. This contact provides a path between the plies. It was also observed, and confirmed by Tyco, that nesting occurs within this stackup. Nesting, which is when glass fibers come into contact with the copper foils, provides the path from the copper to the plies. The combination of these two physical artifacts can create a path for TDDB that is similar to intralayer breakdown as opposed to interlayer breakdown. In this situation, the lower value of dielectric breakdown, approximately 3 kV/mm, may be more appropriate.
