Robustness of Surface Mount Multilayer Ceramic Capacitors Assembled with Pb-Free Solder

Nathan Blattau¹, Patrick Gormally², Vin Iannaccone², Laurence Harvilchuck³ and Craig Hillman¹

ABSTRACT

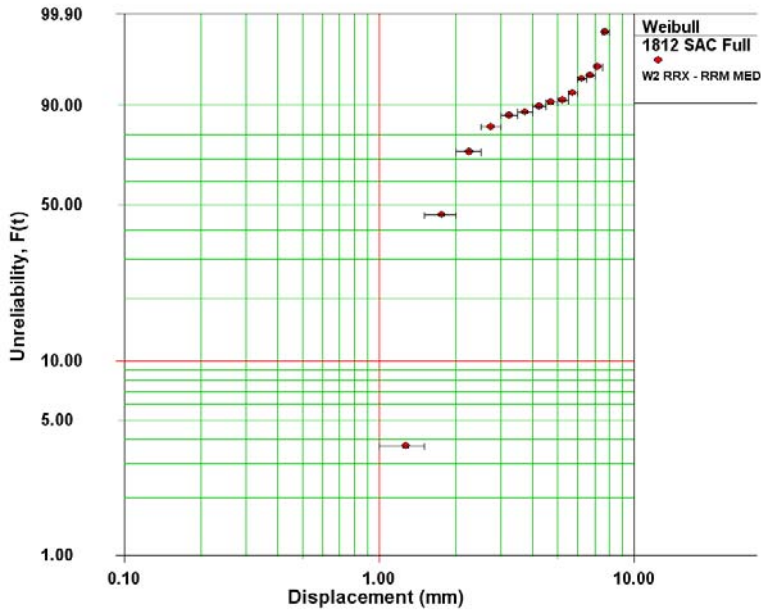
Comparing the data in Table 4 and Table 5, the 1812 size capacitors attached with SnAgCu appear to be more robust than those attached with SnPb solder. A plot of the full data set for the 1812 SnAgCu capacitors is shown in Figure 5.

Figure 5: Failures of 1812 capacitors with SnAgCu solder

Previous studies conducted by J. Bergenthal [22] showed that the failure data for capacitors typically exhibit a bimodal distribution. In his study, the author found it necessary to exclude failures above 50% in order to provide a relevant statistical analysis. To avoid the same bimodal type distribution data above 90% failure (or 4.5 mm displacement) was excluded from the statistical analysis of the 1812 SnAgCu capacitors.

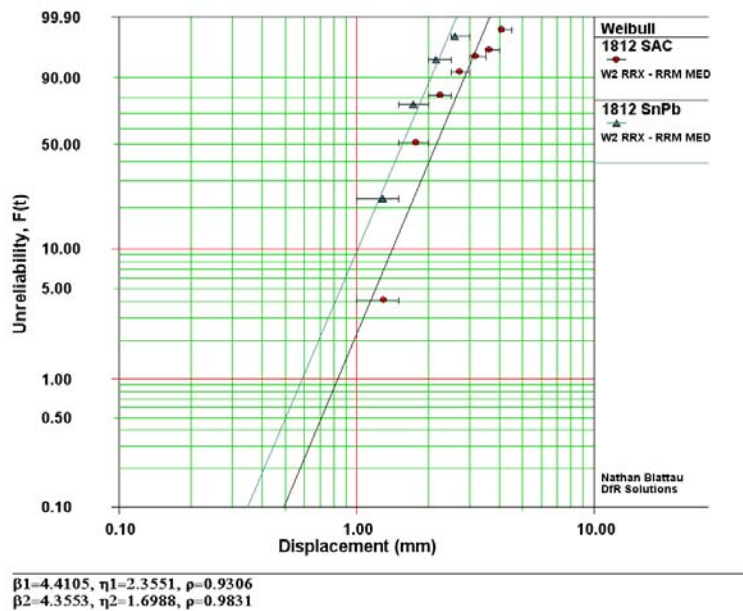
The additional robustness provided by using SnAgCu is clearly demonstrated by the 2-parameter Weibull plot shown in Figure 6. The characteristic displacement (63% failure point) of the SnAgCu 1812 and the SnPb 1812 was 2.36 mm, and 1.70 mm respectively.

The displacement necessary to induce 5% failure for 1812 capacitors attached with SnAgCu solder was 1.5 mm while those attached with SnPb was 0.85 mm.

Figure 6: Weibull plot of 1812 capacitor failures

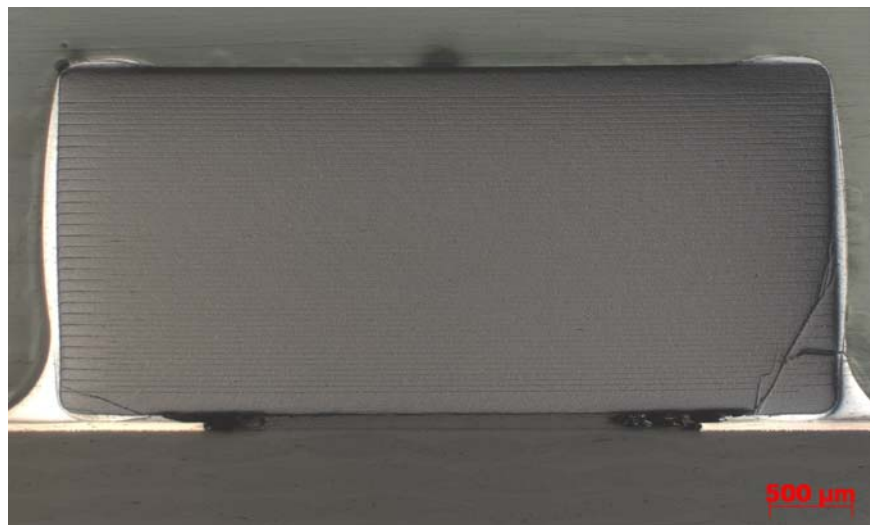
For a ceramic chip capacitor, failure due to printed wiring board bending usually manifests itself as a crack in the body of the capacitor, as shown in Figure 14. The crack may intersect the electrodes of the capacitor causing a decrease in capacitance or an increase in leakage current. Many times the failure is catastrophic with opposing electrodes shorting together and destroying the capacitor. The use of an open-mode ceramic capacitor can significantly decrease the probability of a catastrophic failure if a flex crack occurs.

Figure 14: Flex cracking in a capacitor
