Silver and Sulfur: Case Studies, Physics, and Possible Solutions

C. Hillman, S. Binfield, J. Seppi, and J. Arnold
DfR Solutions
April 15, 2009

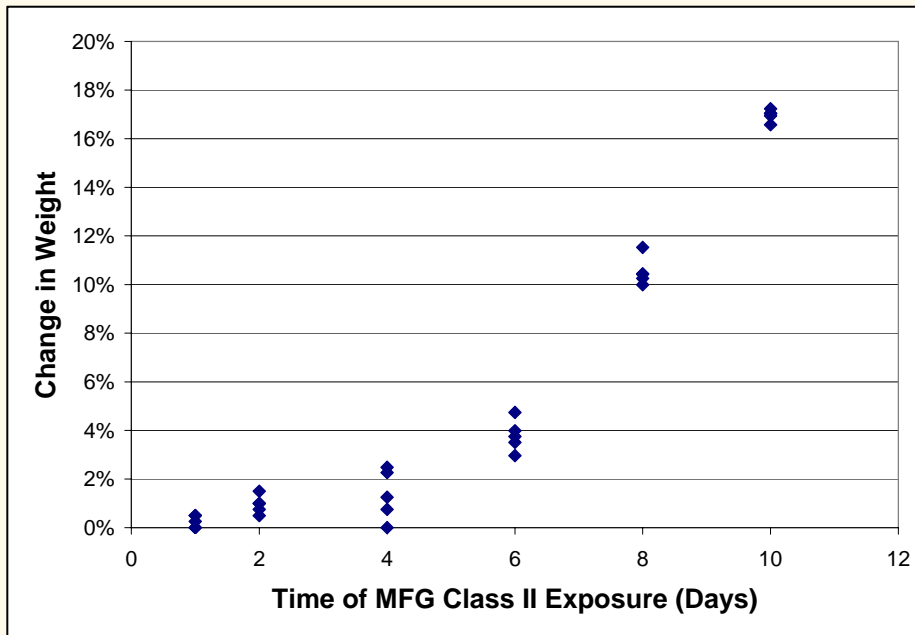
Weight Gain

- Weight gain provides strong evidence of chemical reaction
 - 3X weight gain compared to SnPb HASL coupons
- Change in SIR likely due to moisture absorption
 - Absolute SIR still above 1×10^{12} ohms

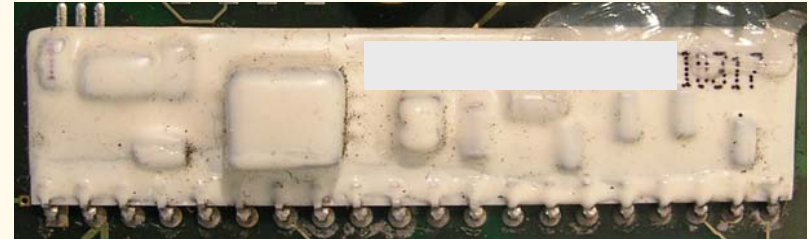
- Silicone encapsulant, ceramic hybrid
- Used in industrial controls
- Customer reported failures after 12 to 36 months in the field
- X-ray identified several separations

'Good' hybrid

'Bad' hybrid

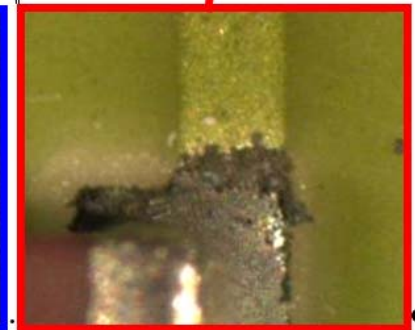
Sulfur Corrosion Sites

- Silicone encapsulant was removed using Dynasol
- Visual inspection revealed black corrosion product throughout the hybrid
 - Most severe in areas with no solder or solder mask covering silver thick film traces
 - Attack through the solder mask in some locations

- Manufacturer added a silicone coating under the silicone potting
 - Will this help?
- Possibly
 - Corrosion primarily occurred in areas where silver thick film traces were exposed
 - Additional coating should slow the reaction sufficiently to provide desired lifetime
- Silicone potting was not successful in preventing sulfidation
 - Silicone coating will have the same open structure (porous)
 - Could allow penetration of corrosive gases (e.g., H₂S)

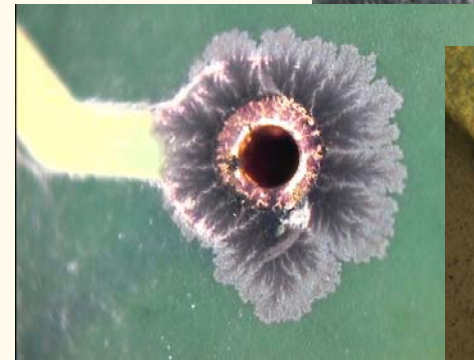
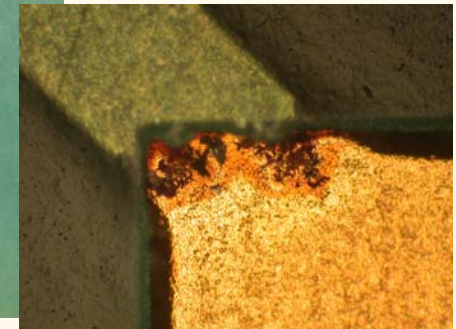
MFG Test Structures

- Influence of solder mask
 - ❑ Field: Creepage primarily on solder mask defined (SMD) pads
 - ❑ Test: Delay in creepage on non-solder mask defined pads (NSMD)
- Similar mechanism observed with electroless nickel / immersion gold (ENIG) plating
 - ❑ Corrosion of copper trace at solder mask edge
- Potential mechanisms
 - ❑ Solder mask absorption of sulfur-based gases
 - ❑ Crevice corrosion (depletion of oxygen)
 - ❑ Entrapment of flux residues

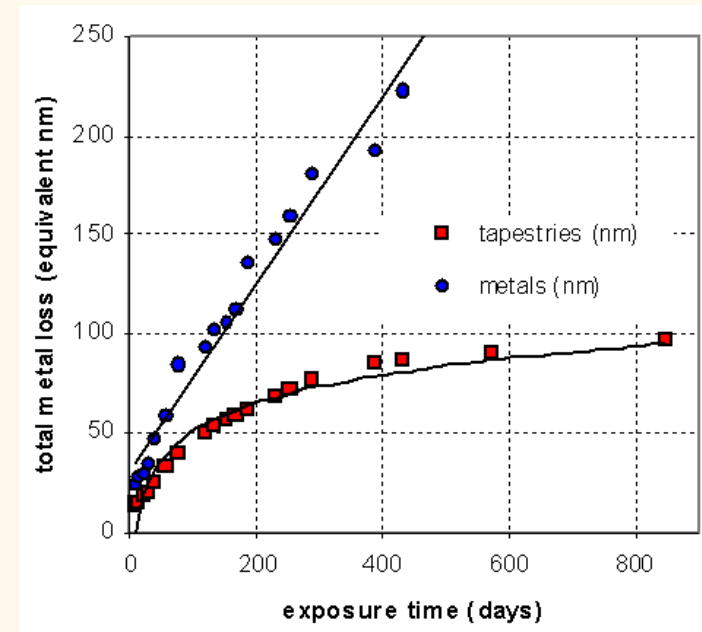
- Modification of MFG test specs may be appropriate
 - Elimination of SO₂ gases
 - Increase in H₂S concentrations (>200 ppb)
 - Possible intro of COS
 - Elimination or reduction of Cl₂
- Speculation that formation of AgCl inhibits sulfidation of silver
 - Elevated Cl₂ displays parabolic behavior
 - Elevated H₂S displays unlimited growth
