SILVER AND SULFUR: CASE STUDIES, PHYSICS, AND POSSIBLE SOLUTIONS

Craig Hillman, Joelle Arnold, Seth Binfield, Jeremy Seppi
DfR Solutions
College Park, MD, USA
askdfr@dfrsolutions.com

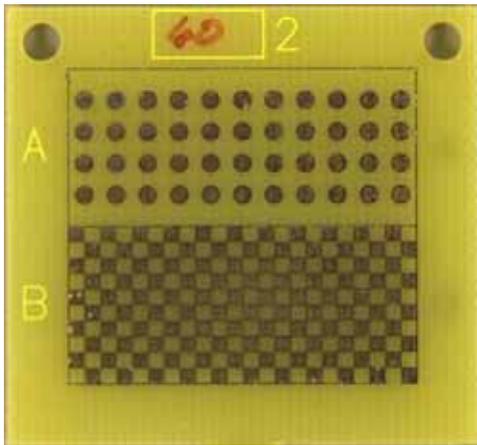
Figure 1: Photographic image of corrosion coupon plated with immersion silver

The first case study provides a baseline to the behavior of immersion silver when exposed to a standard mixed flowing gas (MFG) testing environment. In this case study, corrosion coupons plated with immersion silver were exposed to a Class II, mixed flowing gas environment. An image of the corrosion coupon is shown in Figure 1. The corrosion test coupon had no solder mask and consisted of two arrays. The first array, labeled A, consisted of 44 circular pads, 1.5 mm in diameter, spaced approximately 1 mm apart. The second array, labeled B, consisted of a cross-hatch pattern.

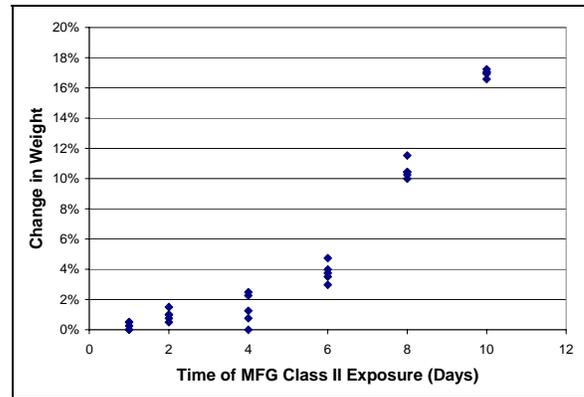
Figure 2: Weight gain of immersion silver coupons after exposure to Class II MFG environment

The weight gain behavior shows strong evidence of chemical reaction, especially in comparison to baseline HASL coupons which gained less than a third as much. Weight gain behavior also seems to show a potential shift in the corrosion mechanism after 6 days of exposure. The change in SIR is much less definitive. Even though the magnitude of change is greater in comparison to weight, the absolute SIR value was still greater than 1×10^{12} ohms.

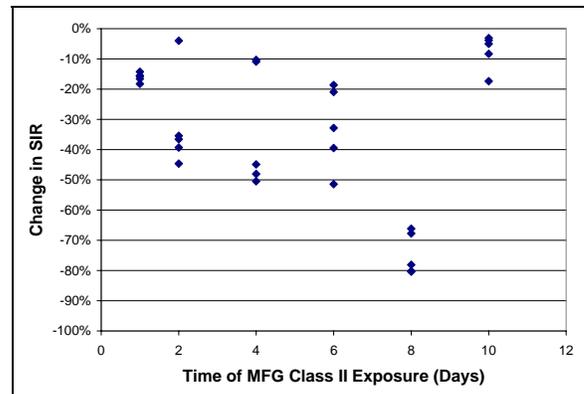
Figure 3: Change in surface insulation resistance (SIR) of immersion silver coupons after exposure to Class II MFG environment

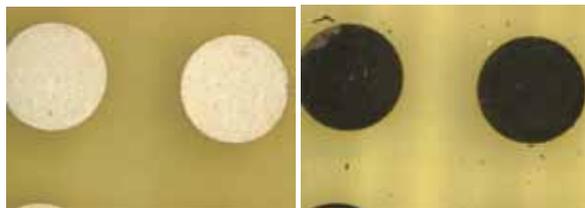
Figure 4: Immersion silver coupons before (left) and after (right) eight days of exposure to Class II MFG conditions

The results of post-exposure examination using optical and electron microscopy are shown in Figure 4 and Figure 5, respectively. The immersion silver turned a strong black after exposure to the mixed gas conditions. Elemental analysis using energy dispersive spectroscopy (EDS) identified both chlorine and sulfur, as well as silver and copper¹. The presence of chlorine and sulfur would seem to suggest the formation of silver chloride (AgCl) and silver sulfide (Ag₂S) compounds. While silver chloride is initially white, when exposed to light it experiences a photoreduction process and disassociates into chlorine molecules and silver atoms. [15] The resulting metallic silver can have a gray-black appearance. Silver sulfide will also have a black appearance. Note that no corrosion products appear beyond the plating area.

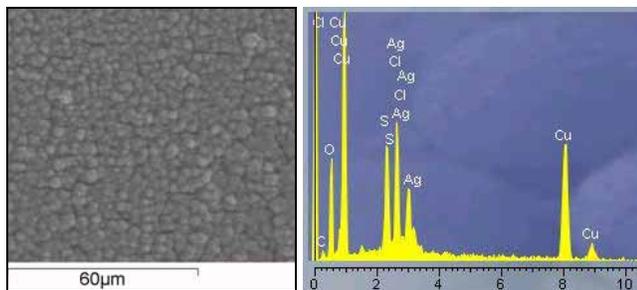
Figure 5: Electron micrograph (left) and elemental spectrum (right) of immersion silver coupon after eight days of exposure to Class II MFG conditions

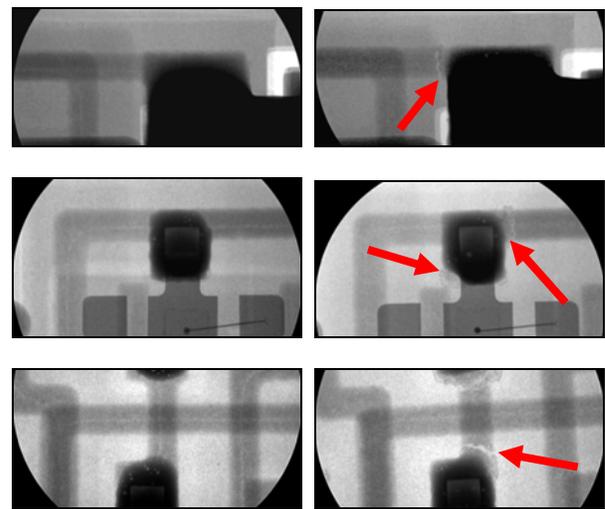
Figure 7: X-ray images of as-received (left) and failed (right) hybrids. Red arrows reveal separations/disruptions in the silver thick film circuit of the failed hybrid.

X-ray of the encapsulated hybrid identified several disturbances or separations in the silver thick film traces (see Figure 7).

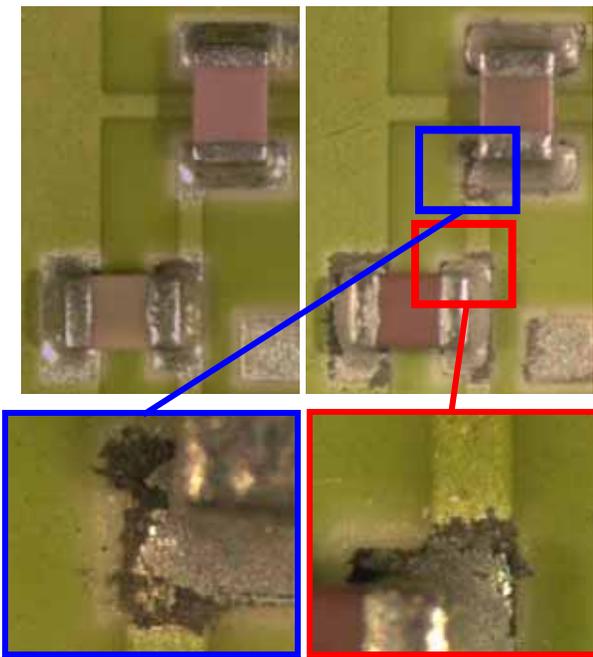
Figure 8: Optical micrographs of decapsulated as-received (left) and failed (right) hybrids.

To better identify the root-cause of separation, the silicone encapsulant was removed using Dynasol. Visual inspection of the decapsulated hybrid revealed a black corrosion product throughout the ceramic substrate. The most severe reactions were areas where neither solder nor solder mask covered the silver thick film traces, though there was some indication of attack through the solder mask in some locations.

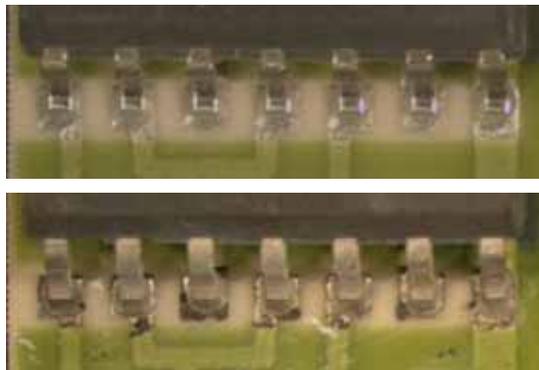
Figure 9: Optical micrographs of decapsulated as-received (top) and failed (bottom) hybrids.

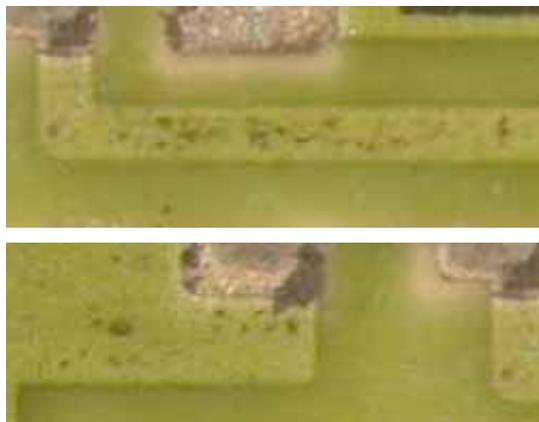
Figure 10: Optical micrographs showing potential corrosion product emanating through the solder mask.

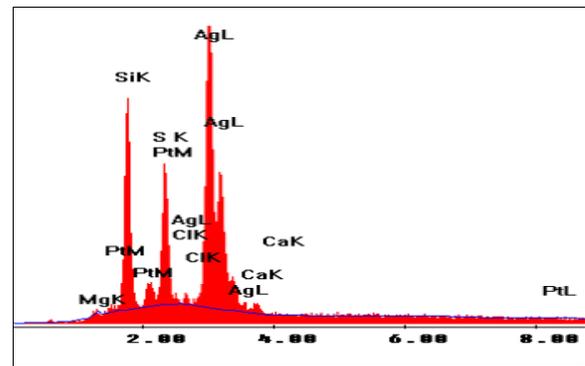
Figure 11: Elemental spectrum of corrosion products identified in ceramic hybrid

Elemental analysis of the corrosion products identified strong sulfur and silver peaks (see Figure 11).

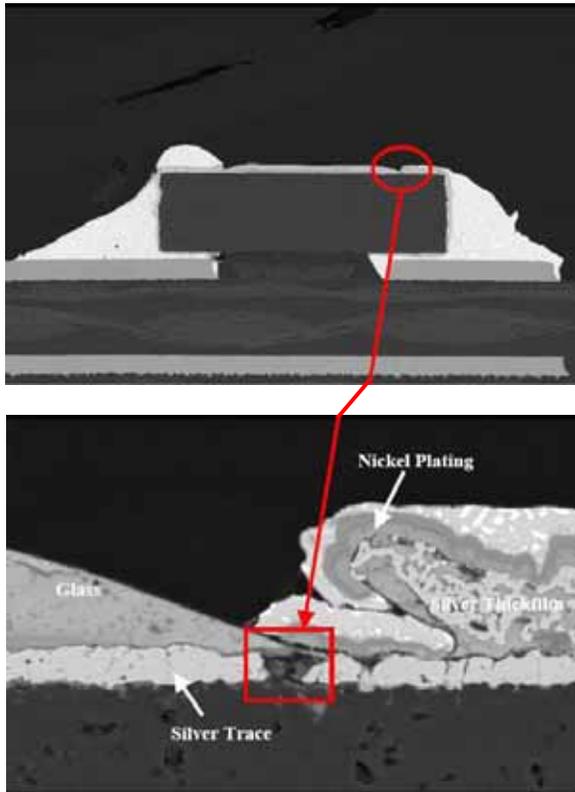
Figure 12: Electron micrographs of a cross-section of a thick film resistor that experienced sulfidation.

As seen in Figure 12, the sulfur-based compounds seem to attack the silver base conductor at the abutment of the glass passivation layer and the resistor termination. Cracks or openings in this location allow the ingress of corrosive gases, which react with the silver to form silver sulfide (Ag₂S).

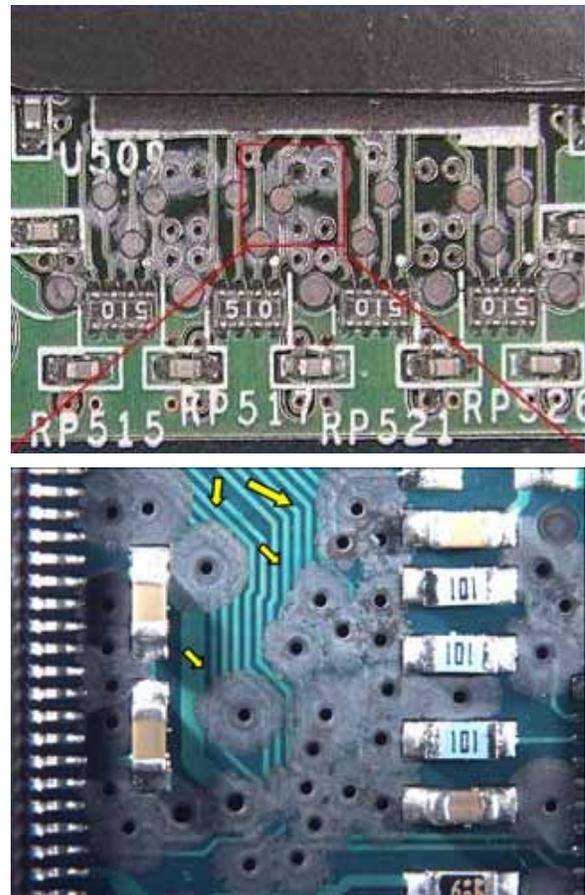
Figure 13: Photo-documentation of sulfur-based corrosion products on PCBs (source of top image: confidential; source of bottom image: ref. 19)

The final case study reviews recent field issues experienced on printed circuit boards (PCBs) plated with immersion silver. Users of these products reported faults within months of installation at field sites. Visual inspection of the failed units identified gray concentric circles emanating from plated through holes.

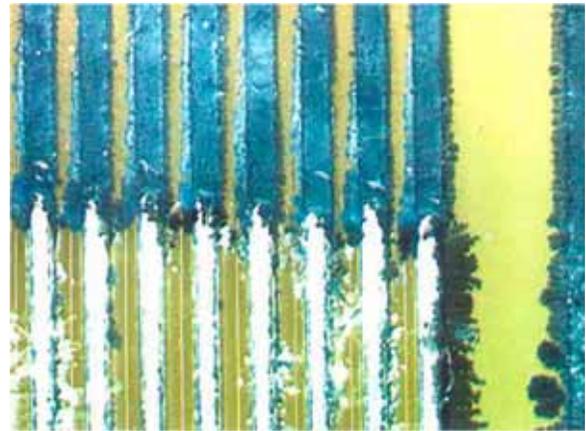
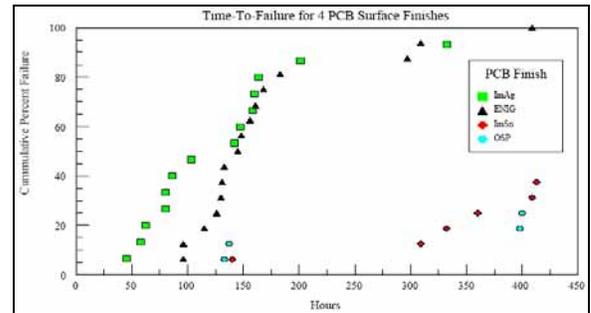
Figure 14: Visual (top) and insulation resistance (bottom) results from exposing immersion silver plated SIR coupons to MFG test conditions [20]

The fourth case study identifies creepage corrosion of silver sulfide corrosion products as the root-cause of field issues. However, creepage behavior was not observed after exposing immersion silver corrosion coupons to Class II MFG tests for up to 10 days (see the first case study). The lack of creepage corrosion in the first case study is in direct conflict with results reported by Veale [20]. In his studies, immersion silver plated surface insulation resistance (SIR) coupons were subjected to a modified Class IIIA MFG and biased with 10VDC. The results are displayed in Figure 14.

The corrosion behavior observed by Veale shows a strong correlation to the morphology seen in the fourth case study. This would seem to suggest that the Class II test condition in the first case study is insufficient for some use environments and Class IIIA may be more appropriate as a general qualification procedure. However, additional work in this area seems to indicate that none of the classifications in standard MFG testing may be insufficient to replicate the field behavior observed in the fourth case study.

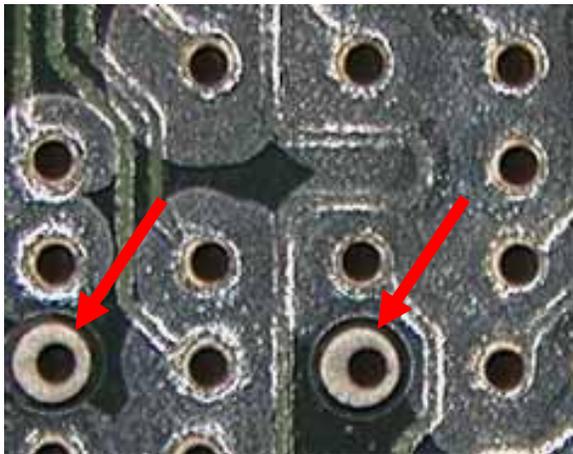
Figure 15: Optical micrograph of immersion silver plated PCBs returned from the field due to sulfur-based corrosion. The red arrows identify NSMD pads that have not experienced sulfidation

Initial observations of field returns due to creepage of silver-sulfide corrosion products identified a unique design influence. Those annular rings that were solder mask defined (SMD) experienced creepage corrosion, while those annular rings not defined by solder mask were relatively corrosion-free (see Figure 15). Additional testing under accelerated conditions demonstrated that this phenomenon seems to simply delay the mechanism and non-solder mask defined (NSMD) silver-plated structures eventually experience corrosion behavior.

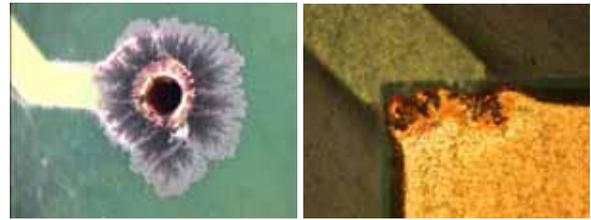
Figure 16: Optical micrographs of corrosive growths observed on ENIG-plated PCBs

This solder mask specific dependence has been observed in similar corrosion mechanisms that initiated on the surface of a printed circuit board (PCB). As seen in Figure 16, corrosion products were observed emanating from the copper structures at the boundary of the solder mask. In this situation, the solderability plating is electroless nickel / immersion gold and the driver for the corrosion is the presence of plating residues on the surface of the PCB.

However, the morphology and coloration of the growths are very similar to the sulfidation of immersion silver.

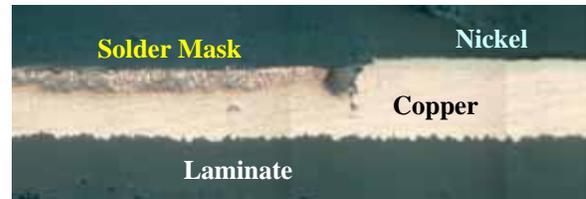
Figure 17: Optical micrograph of cross-section of ENIG-plated bond pad experiencing crevice corrosion

Additional characterization of the corrosion sites through cross-sectioning suggested crevice corrosion due to the loss of copper under the solder mask directly adjacent to the solder mask boundary (see Figure 17).

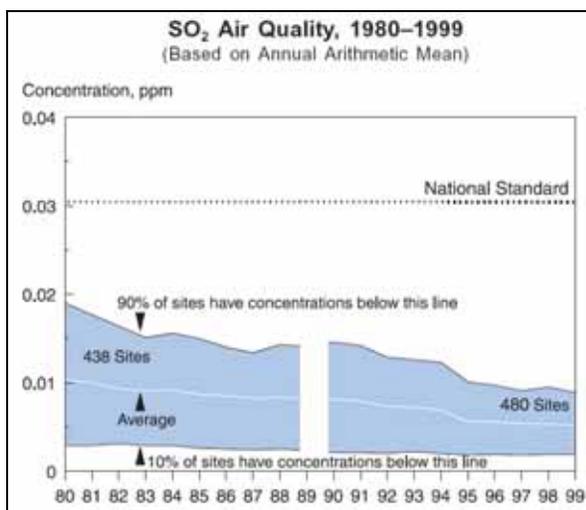
Figure 18: Latest Findings on National Air Quality: 1999 Status and Trends, Environmental Protection Agency (Office of Air Quality Planning and Standards) August 2000, Research Triangle Park NC 27711 EPA-454/F-00-002

Information from the EPA on annual average concentrations of SO₂ are provided in Figure 18. The national standard is 30 ppb for SO₂. It can be seen that historically, the actual SO₂ concentration has been far less, with ranges from 2 to 19 ppb. This has decreased over time to the point that the 90 percentile value for SO₂ is less than 10 ppb. This is not the case for recently industrialized countries in East and Southeast Asia. Average outdoor levels in Asian ‘Megacities’ have been found to vary between 25 to 100 ppb, with short-term maximum values increasing those levels by a factor of 4 to 16 [25].

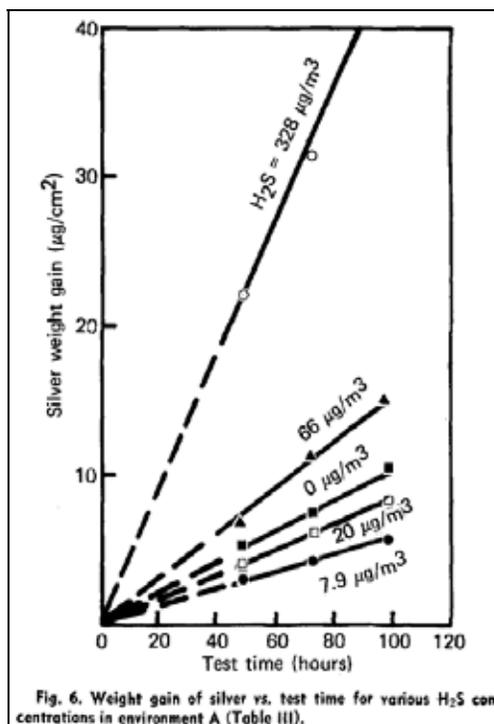
Fig. 6. Weight gain of silver vs. test time for various H₂S concentrations in environment A (Table III).

Figure 20: Weight gain of silver as a function of H₂S concentration [41]

H₂S concentrations are critical in the sulfidation reaction of exposed silver. As seen in Figure 20, material changes in silver during exposure to H₂S displays a linear behavior and a strong dependence on H₂S concentration.

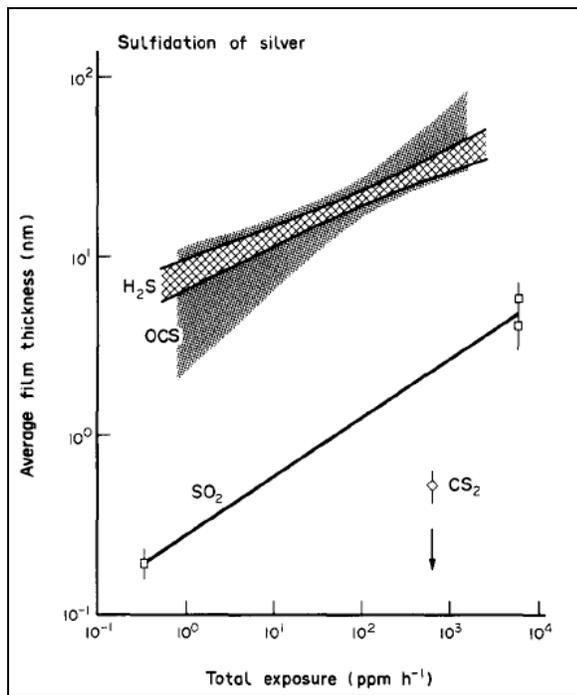
Figure 21: The thickness of Ag₂S corrosion film as a function of total exposure to H₂S, OCS, SO₂ and CS₂. All exposures were made with RH = 92 ± 4%, t = 21 °C [34].

COS can also be as corrosive as H₂S in regards to its reaction with silver. As shown in Figure 21, COS induces approximately the same rate of corrosion product generation as H₂S as a function of total exposure.

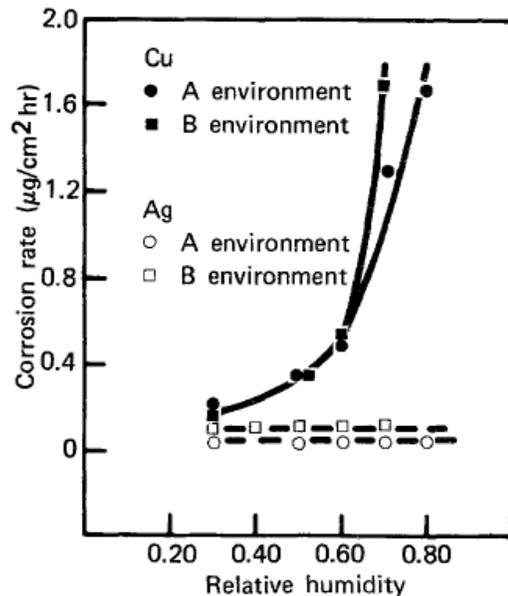
Figure 22: Corrosion rates of copper and silver as function of relative humidity during exposure to A (810 ug/m³ SO₂, 940 ug/m³ NO₂, 334 ug/m³ O₃, 8.5 ug/m³ Cl₂, 21 ug/m³ H₂S) and B (860 ug/m³ SO₂, 990 ug/m³ NO₂, 8.5 ug/m³ Cl₂, 17 ug/m³ HCl, 54 ug/m³ H₂S) environments [41].

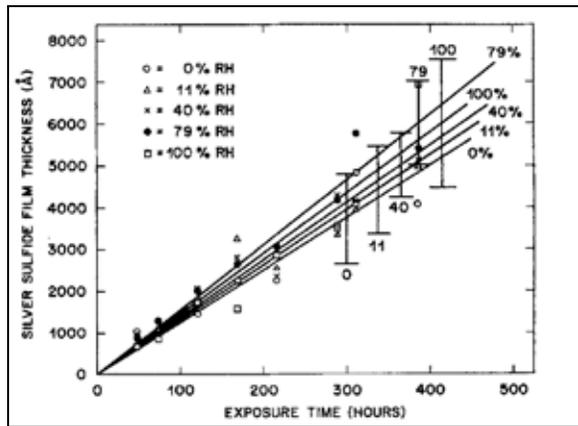
Figure 23: Thickness of silver sulfide film as a function of relative humidity [42]

Sinclair [43] provides some nuance to this argument by demonstrating similar reaction rates in environments with high and low relative humidity until the silver sulfide film reaches approximately 60 nm thickness.

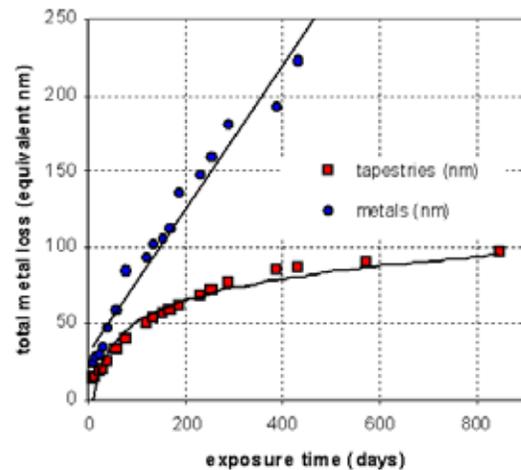
Figure 24: Corrosion rate of silver as a function of exposure time and ambient environment (tapestries had elevated levels of Cl₂; metals had elevated levels of H₂S)[44]

Dubus [44] demonstrated that in environments with elevated levels of chlorine gas, relative to sulfur-based gases, the corrosion behavior is dominated by the formation of AgCl, which follows a parabolic corrosion law. This time-dependent behavior, indicates that the corrosion rate is limited by the diffusion of chlorine through the film, resulting in the formation of a fully protective corrosion layer.

By comparison, silver in environments with elevated levels of reducing sulfur-gases shows a linear behavior, suggesting unlimited growth potential (the type of behavior required for creepage corrosion).
