Improved Methodologies for Identifying Root-Cause of Printed Board Failures

C. Hillman

DfR Solutions, College Park, MD

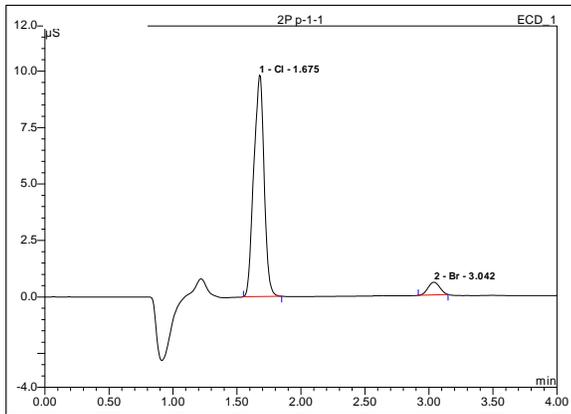
Figure 16: Output from an ion chromatograph showing peaks of chloride and bromide based upon retention time

These elevated levels of bromide exceeded all recommended maximums detailed in Table 6. While the board supplier was requested to respond to the relatively high levels of chloride and bromide on the bare board, further investigation focused on the source of the elevated bromide level after the application of the conformal coating.

Often, the presentation of these findings is sufficient to initiate discussion with the supplier on the appropriate actions to remedy and remove these failure accelerators from future product. However, in this case, the supplier responded with their own ion chromatography results, claiming that sampling of bare boards at their facility resulted in bromide and chloride values well within industry specifications.
